**STATE OF NEW JERSEY**  
**Board of Public Utilities**  
44 South Clinton Avenue, 9<sup>th</sup> Floor  
Post Office Box 350  
Trenton, New Jersey 08625-0350  
[www.nj.gov/bpu/](http://www.nj.gov/bpu/)

IN THE MATTER OF THE JOINT APPLICATION OF )  
OAKWOOD VILLAGE SEWERAGE ASSOCIATES, )  
L.L.C. AND AION OAKWOOD SEWER, L.L.C. FOR )  
APPROVAL OF A TRANSFER OF CONTROL OF A )  
PUBLIC UTILITY ) DOCKET NO. WM15091006

**Oakwood Village Wastewater Treatment Plant**  
**Final WWTP Condition Assessment**

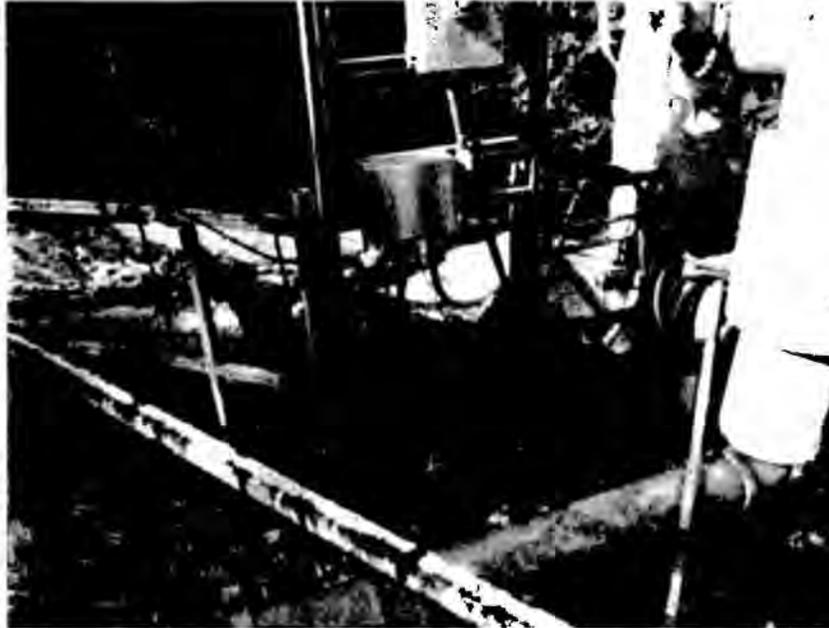
Figure 2 Treatment Tank

2. The interior condition of the tank is unknown. The operator reports that the tank likely has an accumulation of settled solids based on the condition of the removed sludge pump.
3. The access stairs, upper walkways, grating, handrails and walkway support steel is a combination of painted and galvanized steel. The painted steel shows significant rusting (see Figure 2). Some galvanized steel is showing signs of rusting.

4. Piping is a combination of PVC, steel, ductile iron and hoses. The painting on the steel and iron pipes is failing and the pipes are rusting. Some pipes are insulated and the insulation is in adequate condition; however, some minor repairs are needed. It is unknown if the insulated piping is also heat traced.
5. The Recirculation Pumps were installed as part of the 1998 upgrades. The operator did not know if the pumps were original. The operator was not aware of any current issues with the pumps. The Sludge Pump was currently out of service. As a result, the normal method of sludge removal had been modified. Sludge was being wasted to the screening tank which are accessed by small tank trucks for removal. Electrical equipment on the Treatment Tank access platform is in fair condition. Most panels are corrosion resistant. Steel panels are showing signs of rusting. Some

1. The access stairs, platform, handrails and structural steel should be cleaned and painted to extend their useful lives.
2. The Treatment Tank should be drained, cleaned and inspected. The interior of the tank will likely require painting.
3. The exterior painting should be spot repaired. However, if during inspection of the tank interior it is found the tank needs painting, the exterior should be painted at the same time.
4. The sludge pump should be replaced and put back in service.
5. When the tank is drained and cleaned, aeration piping should also be inspected and painted or replaced as needed.
6. Aerators and should be replaced when the tank is drained and cleaned.
7. All metallic piping shall be cleaned and painted. Insulated piping should have the insulation removed and the condition of the pipe and pipe coating be inspected and repaired if needed.

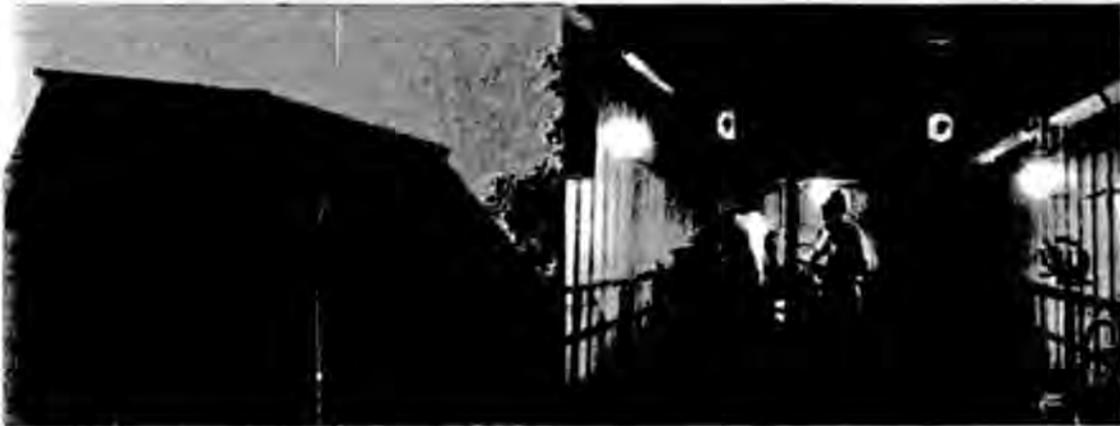
**Figure 4 - Filter Building Exterior and Interior Walls**

1. The Filter Building is a wooden frame and metal skin construction. The building skin panels are show in Figure 4.

- a. The outside and inside skin of the building appear to be in good condition. The building wooden frame was not visible and its condition is unknown. Buildings of this type of construction typically have a life of 20 years under normal conditions. With the high moisture atmosphere and reduced ventilation building deterioration may be accelerated. As the building supports were hidden by both the interior and exterior panels the condition of the wooden structure is unknown.

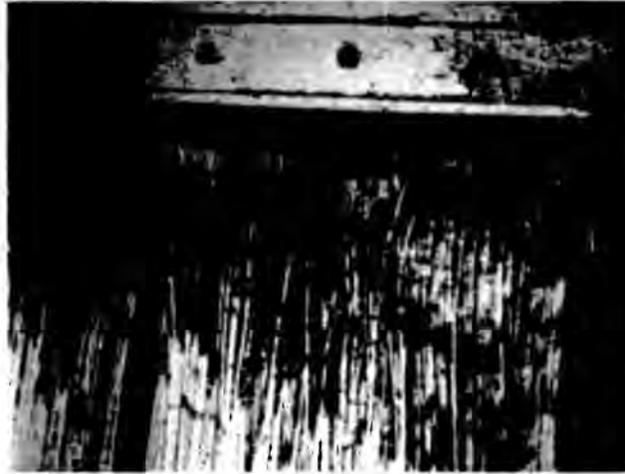
**Figure 7 - Membrane Removed from Service Due to Solids Fouling**

- a. The operator reported that the tank contained 5 racks of membranes with each rack containing 8 membrane cassettes.
- b. 4 of the 5 membrane racks were replaced 1.5 years ago. The 5<sup>th</sup> rack is in need of replacement. This older membrane rack is failing, leading to poor effluent quality.
- c. The tank contains five sections, each containing one membrane rack. Only four of the sections are in operation while the fifth section is used for membrane storage. The membrane type used are tubular. These are small diameter tubes that filter the water from the outside in (See Figure 7 below).
- d. Recent problems with the influent grinder and membrane tank influent screen have caused significant membrane fouling with solids. The operator reports that membranes are cleaned almost daily. Excessive solids can lead to membrane failure and poor water quality.

- e. The membrane product used at the site is now obsolete with only limited availability.
- f. Based on information from the membrane manufacturer, GE, there is a new membrane rack and cassette assembly that can be used in the existing tanks, both for short term and long term conditions.

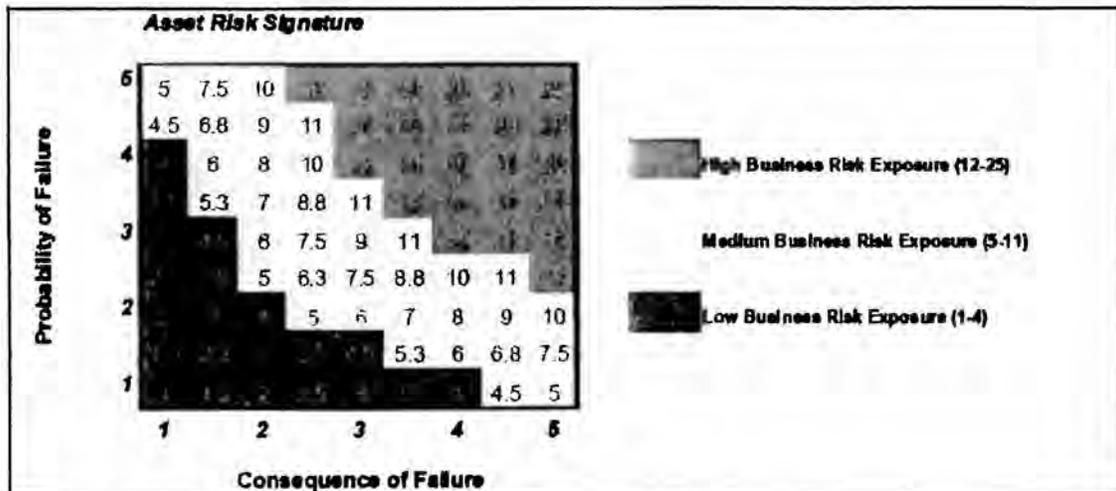
Figure 11 - Asset Risk Signature

A asset assessment matrix was prepared for the major WWTP process facilities. Appendix A discusses the methodology applied in assessing risk levels for the major assets. The probability and consequence of failure scores were assigned based on asset age, condition, function and criticality. The Asset Assessment Matrix is located in Appendix A and summarizes the process components and their associated risk exposure scores , which assists in identifying system needs.

Risk levels have been assigned to each asset at the WWTP. The assessment and ranking or risk levels are based on the product multiplication of the ranking of the Probability of Failure (POF) and Consequence of Failure (COF) as shown in the Asset Risk Signature table shown below. See Appendix A for a more detailed description of the Risk-based Asset Management approach.

In order to bring the plant up to operating condition, it is recommended that assets which are assigned high and medium business risk exposure ratings be repaired or replaced. The following Table 3-1 summarizes the WWTP assets with the highest business risk exposure rankings. The items with the highest risk rankings are priority for repair and/or replacement; however, it is recommended that all items which are assigned a business risk exposure ranking of 10 or more be addressed.

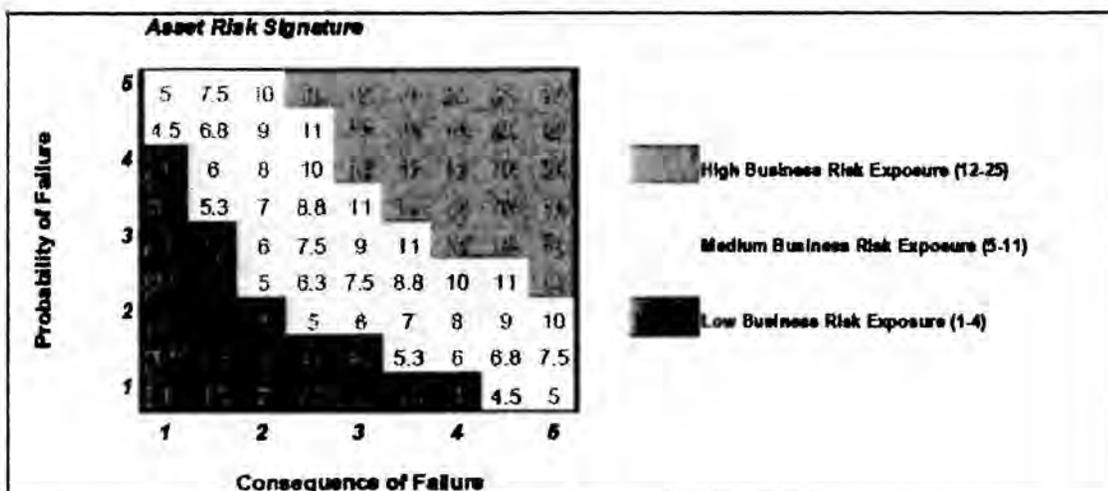
Figure 2: Asset Risk Signature

Risk levels were assigned to each WWTP facility asset. The assessment and ranking of risk levels are based on the product multiplication of the ranking of the Probability of Failure (POF) and Consequence of Failure (COF) as shown in the Asset Risk Signature table (see Figure 1).
